Roofing and Waterproofing Case Study: Milwaukee Public Schools

Project Name: Milwaukee Public Schools

Location: Throughout Milwaukee

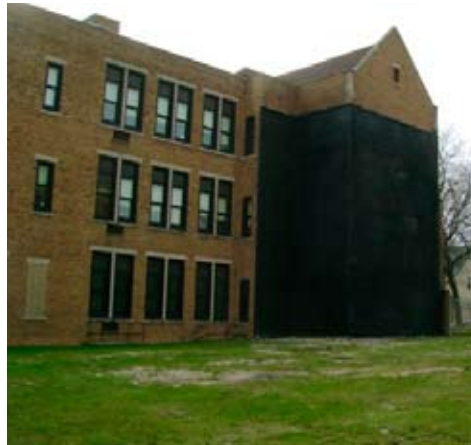
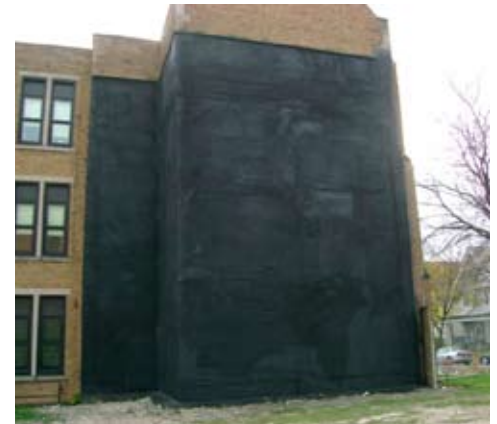
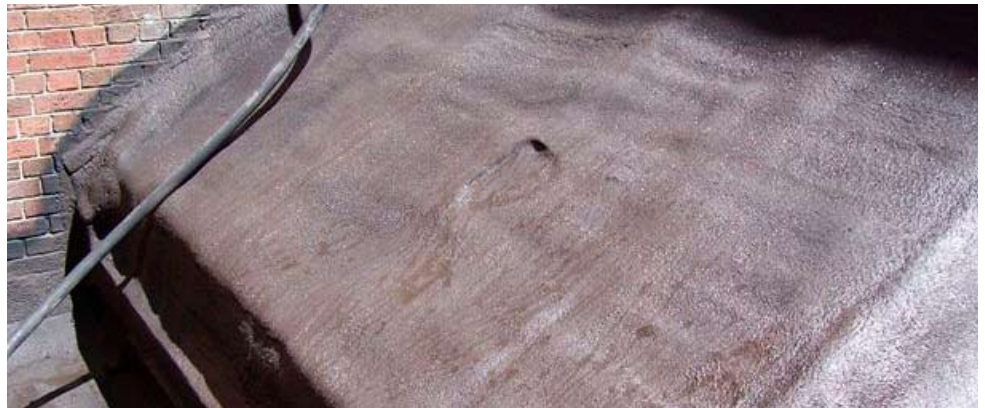
Before

The roofing division at MPS (Milwaukee Public Schools) had been looking for a coating to solve a specific challenge for years. 20 years ago, roughly 250,000 sq.ft. of skylights had been coated with 2" of spray polyurethane foam (SPF). Over the last 5 to 10 years the SPF has been cratered by UV and the elements. It began absorbing water like a sponge.

Dennis Fula and Jim Coney had a worst case scenario. Year after year, more and more SPF was failing. The saturated foam was getting dangerously heavy on top of the glass skylights. They wanted to find a way around the labor of tearing off the foam and the dangers of breaking the glass substrate in the process. The insulative properties of the SPF kept the heat loss in the buildings at a minimum as well.

Neptune Coatings advised MPS to pressure wash the skylights clean, remove the delaminating topcoat from the foam, and tarp the skylights to allow them to dry out prior to the first job. The foremen, Dennis and Jim, chose to disregard all prep on the first 8000 sq.ft. and challenge Wetsuit with a "worst case scenario" situation. The soggy, dirty foam received only a "once over" with a leaf blower. On heavily cratered foam, the Wetsuit 1-Part material was used because of its slow cure and self leveling properties. On the smoother faced foam, Wetsuit 2-Part was used because of its instant cure.

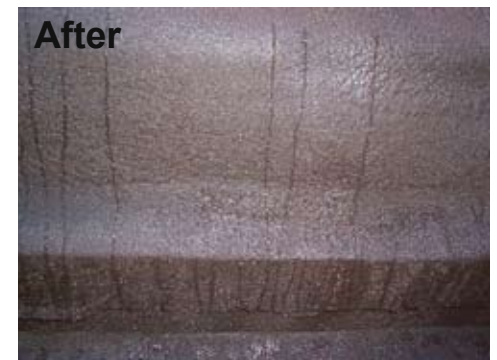
After

As Neptune Coatings predicted, the Wetsuit blistered rapidly in the summer heat, vaporizing the water that was saturating the SPF. Dennis Fula just smiled and nodded his head with satisfaction. "I knew the Wetsuit would blister because of the conditions, all the other coatings did too, but Wetsuit was the first product that blistered but didn't pop!!" Indeed, the 1600% elongation simply ballooned out, vaporizing the water upwards and allowing it to pass out the vents that were installed around the skylights. When all the water vapors were out, the blisters just settled out and the Wetsuit was silver top coated. The ease of application and small crew, gave MPS the labor savings they were looking for as well as a lightweight, monolithic
